No.: SM 03-2008

Date: 03. September 2008

Safety issues with hydraulic cylinders

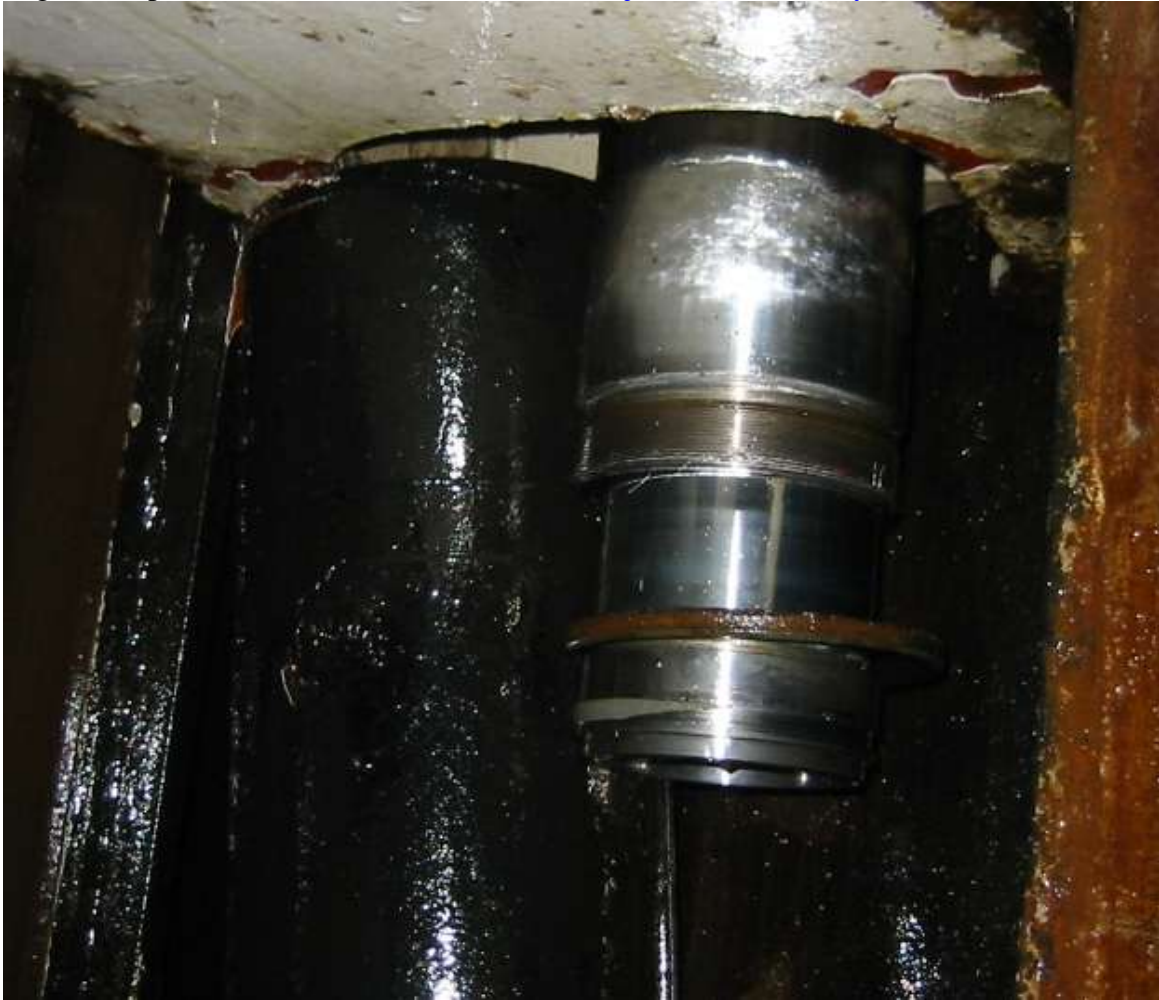
The lifting cylinder was a telescopic cylinder with 4 pistons. Each piston consists of a guide ring (the piston) and a stop ring attached at the cylinder end of the piston. The stop ring is threaded on to the piston and the threads are secured by the application of lock fluid.

The stop ring became undone from piston number 2 as a result of it starting to unthread itself from the piston. This process continued until there was only a fraction of the threaded area that was engaged. When the telescopic cylinder was operated, the force exerted on the piston exceeded the strength of the remaining overlapping threaded area, resulting in the collapse of cylinder number 2. Piston number 2 became disconnected with the cylinder and the suspended deck fell down.

Inspections of cylinders must be carried out as soon as possible in order to uncover defects in connections on telescopic cylinders. The required method of inspection must be clarified with the manufacturer in each individual case, but will typically consist of verification of the length of stroke according to the manufacturers specifications. The need to establish further safeguarding, for instance mechanical locking of threaded connections, should also be discussed with the manufacturer of the equipment.
